Front-End Misalignments and MEBT Trajectory

Stuart Henderson

April 8, 2003

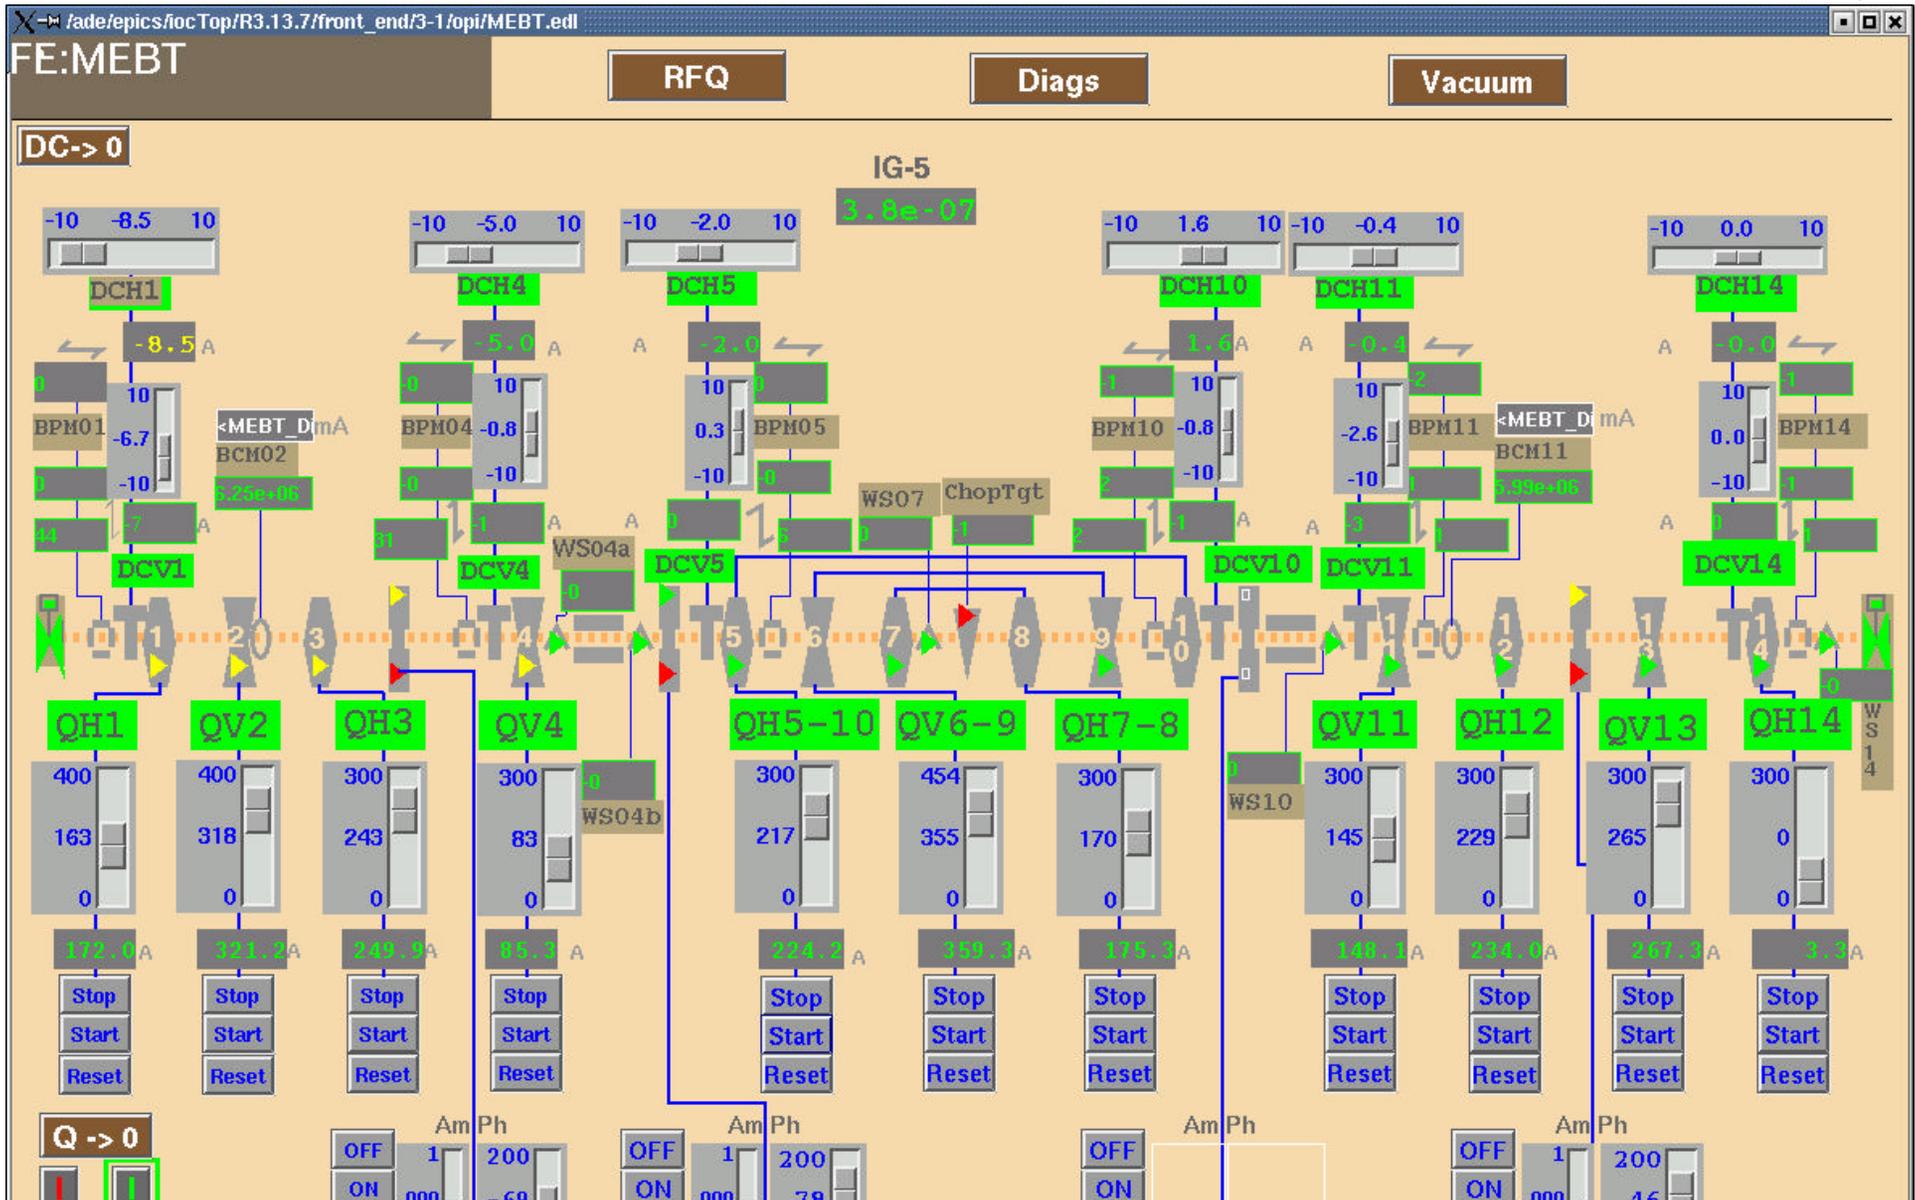
Typical MEBT Corrector Settings

- An outstanding issue from Front-end commissioning at ORNL relates to several MEBT trajectory observations
 - Measured trajectories with MEBT correctors “off” showed large errors
 - Strong or full-strength MEBT correctors required to straighten trajectory
 - MEBT trajectory seen to depend on RFQ power
 - MEBT output emittance shows extreme dependence on MEBT trajectory
- Very important to understand the trajectory
- A number of people have worked on aspects of this problem

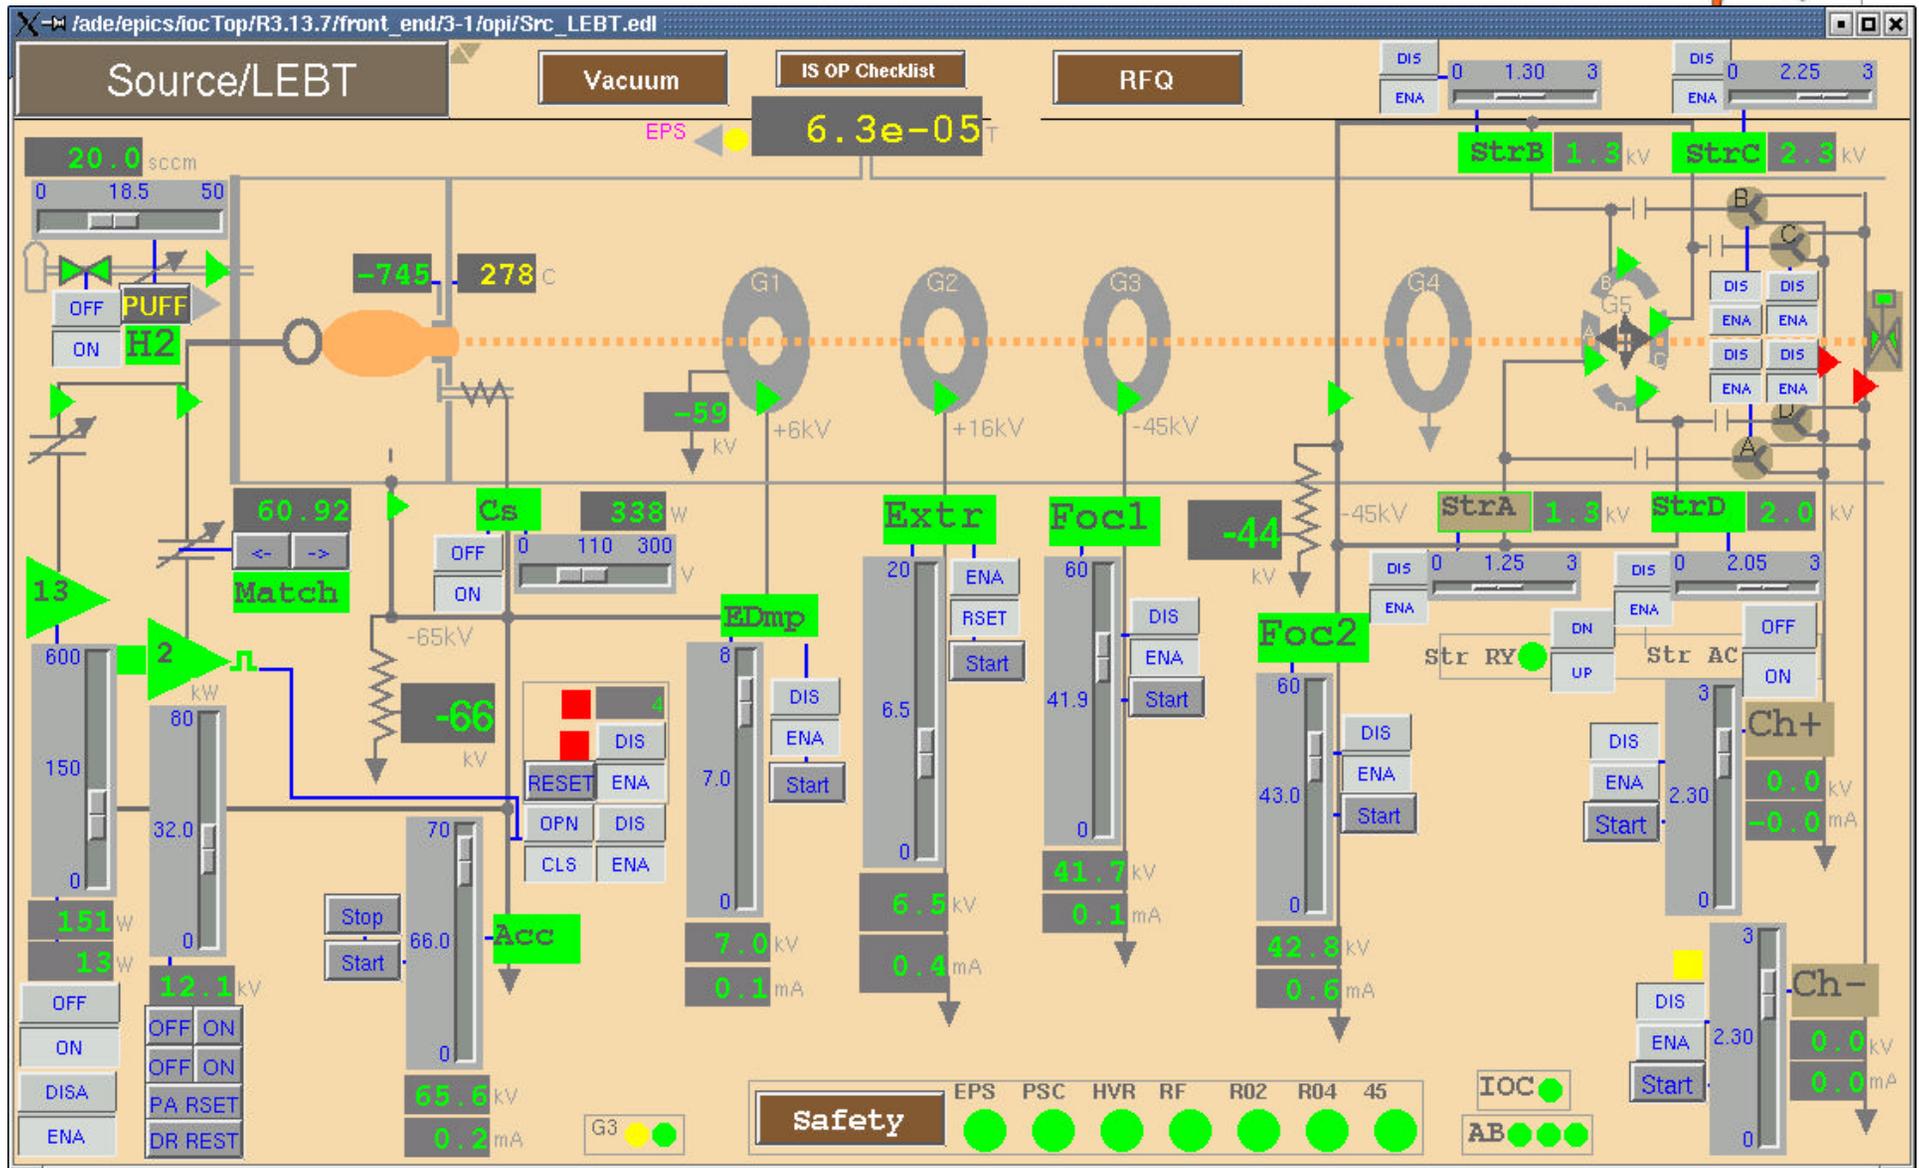
Typical LEBT Settings

- We attempted to align IS/LEBT to RFQ with beam-based transmission and MEBT trajectory measurements
- We measured conflicting, irreproducible results
 - Observed MEBT trajectory to move on its own following LEBT flange position adjustment
 - Recent news: survey reveals LEBT flange relaxation over 20-30 minute period (Stockli, Error,...)
 - Not so recent news: Upon opening LEBT during commissioning found loosened screws, failed glue joints (Stockli, Welton, ...)
- We commissioned with the IS/LEBT to RFQ “randomly” misaligned with no way for in-situ alignment.
- After shutdown, Survey group measured following LEBT to RFQ position:
